INSTALLATION INSTRUCTIONS

SUBJECT: CHARGING CIRCUIT HARNESS FOR 2011-2016 FORD 6.7L POWERSTROKE

FPE-2024-127
July, 2024
Page 1 of 4

FITMENT: 2011-2016 Ford F-250/350 Pickup Trucks with 6.7L Power Stroke

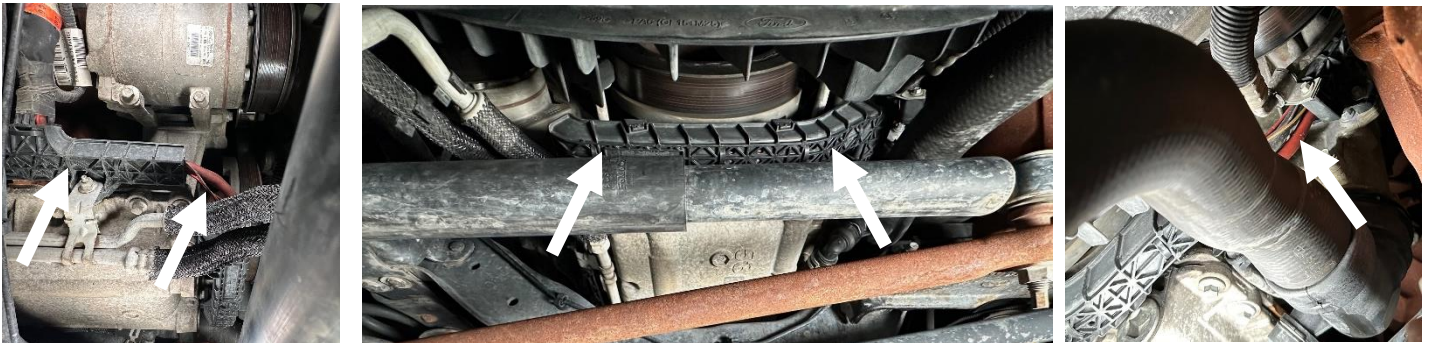
CAUSE: Damaged, stressed, chafed, or broken charging circuit sense wires in the OEM harness that are routed from the Powertrain Control Module (PCM) to the alternator resulting in an intermittent or continuously low voltage reading to the PCM.

DESCRIPTION: Due to the routing, exposure, and general lack of protection on the small charging circuit sense wires that are routed from Powertrain Control Module (PCM) to the alternator it is common for wire damage to be experienced. The routing of the OE harness is cumbersome and extremely difficult to replace and diagnose. Images below show the routing location of the wires in the plastic channel located on the underside of the engine as well as exposed in sections between the channels. These locations are also subjected to vibration and harsh weather and environment, resulting in shortened service life. Images of the routing location of these wires on the underside of the engine are shown below.

FIX/SOLUTION: The Fleece Performance Charging Circuit Harness for the 2011-2016 Ford F250/350 with 6.7L Powerstroke is a drop-in replacement to replace a failed factory harness causing an intermittent or illuminated charging circuit MIL on the dash. The harness installs directly in line with the factory connections with no cutting or splicing and allows you to reroute the alternator connection along the top side of the engine, avoiding the unprotected channel routing on the underside of the engine.

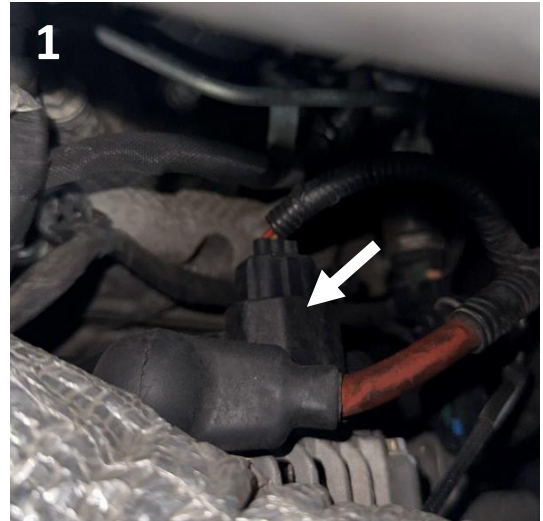
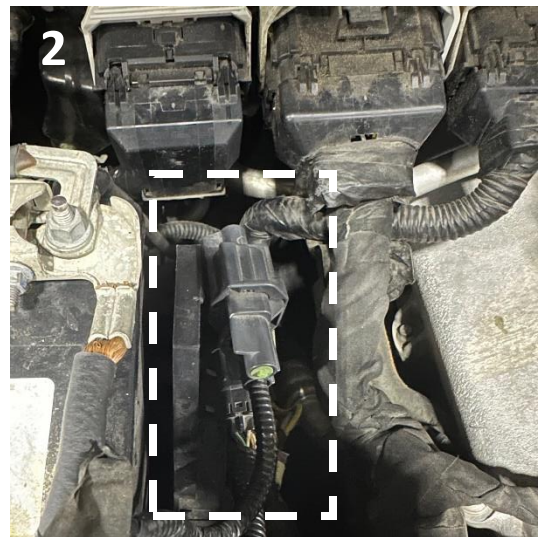
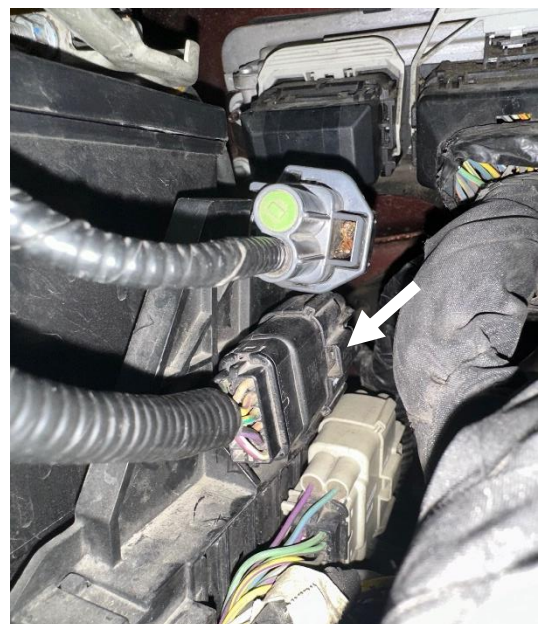
STEP 2: Locate the PCM which is mounted on the passenger side firewall. There will be a bank of three connectors secured to the right side of the battery tray that are located directly below the PCM.

Locate the black, 12-pin connector body, it will be the second connector down from the top. Release the locking tab for the connector body and separate the connector.

Note: To aid in dis-connection of the connector, the connector body may be removed from the mounting bracket by releasing the locking clip on the bracket and sliding the connector backwards.

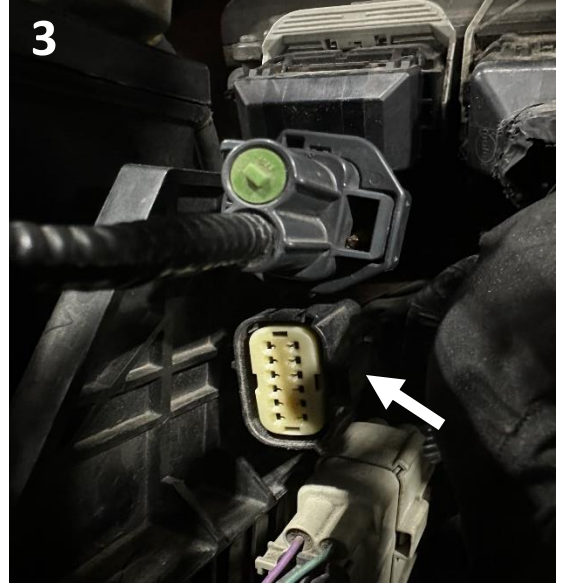
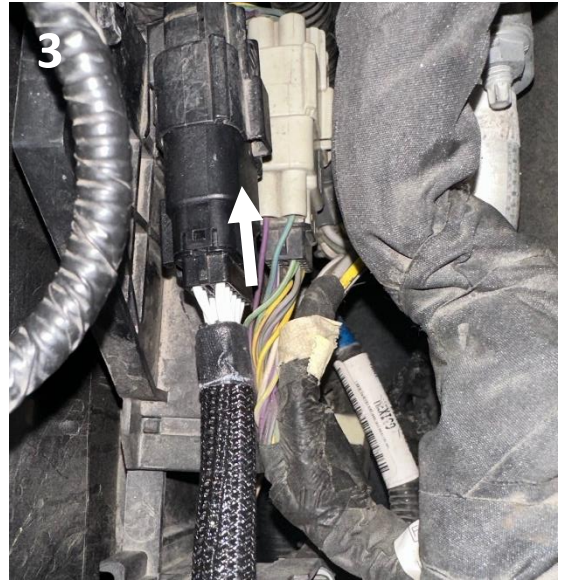
STEP 3: Install the interconnecting portion of the new charging circuit harness to the PCM side connector.

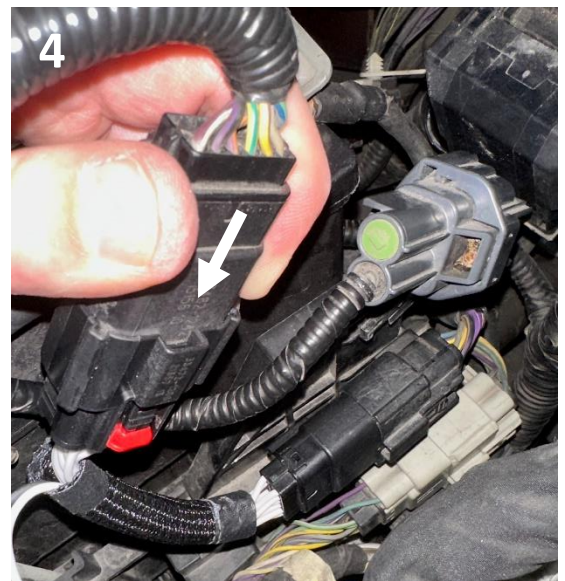
STEP 4: Install the chassis side connector into the new charging circuit harness.

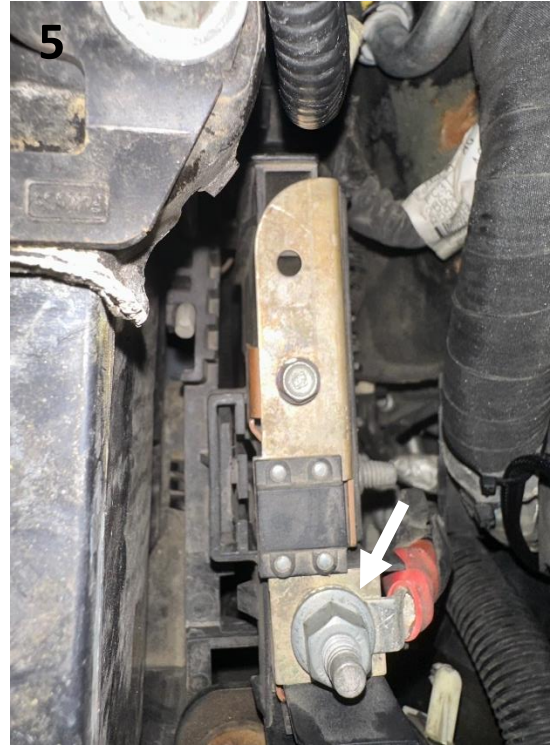
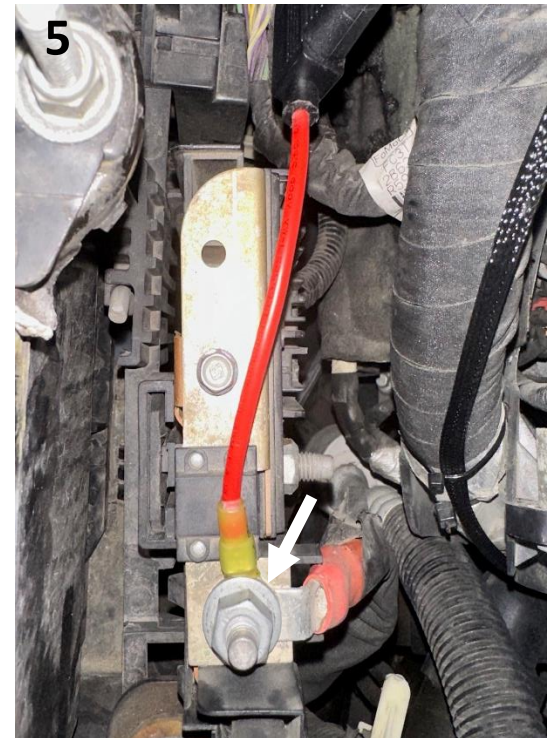
STEP 5: Locate the bus bar on the inboard side of the passenger side battery. Remove the plastic cover. Using a 10mm socket, remove the nut retaining the positive cable. Install the new voltage sense lead on the charging circuit harness and reinstall the retaining nut. Reinstall the plastic cover.

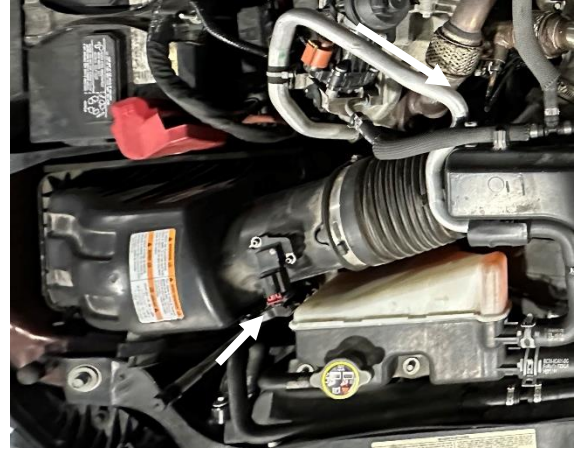
STEP 6: Disconnect the mass airflow sensor connector on the top of the air filter. Disconnect the top of the airbox and loosen the hose clamp around the air intake manifold. Remove the air intake hose to allow for clearer access and routing of the alternator signal wire.

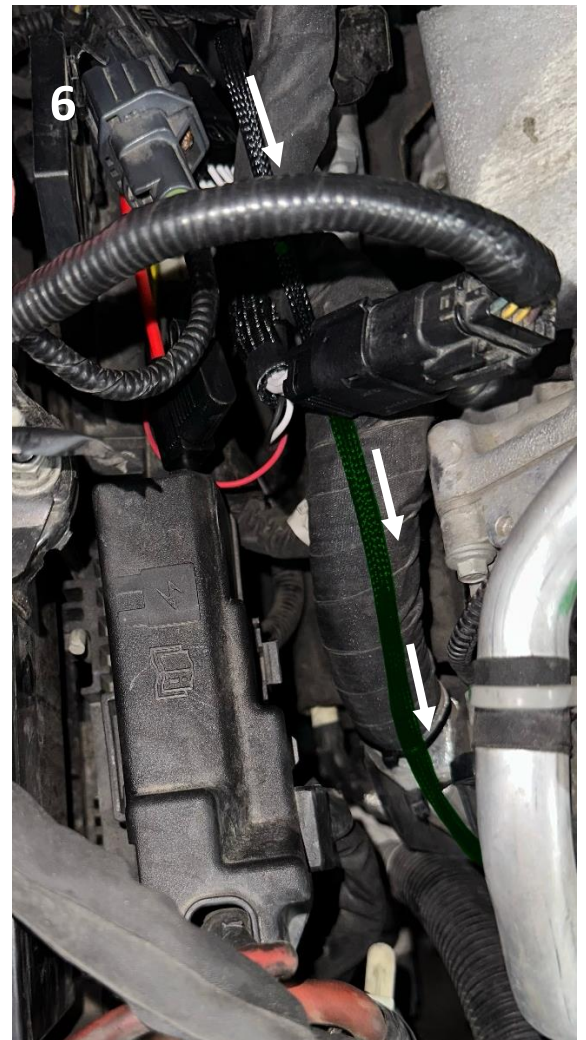
STEP 7: Route the alternator signal wire along the main electrical harness as shown at right. Use zip ties to retain the wire to the harness.

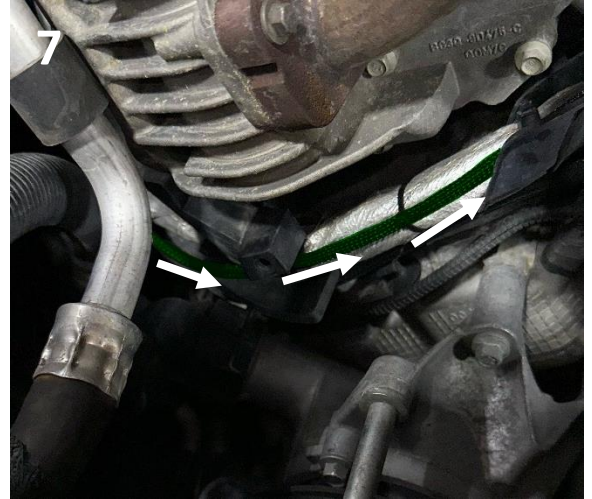
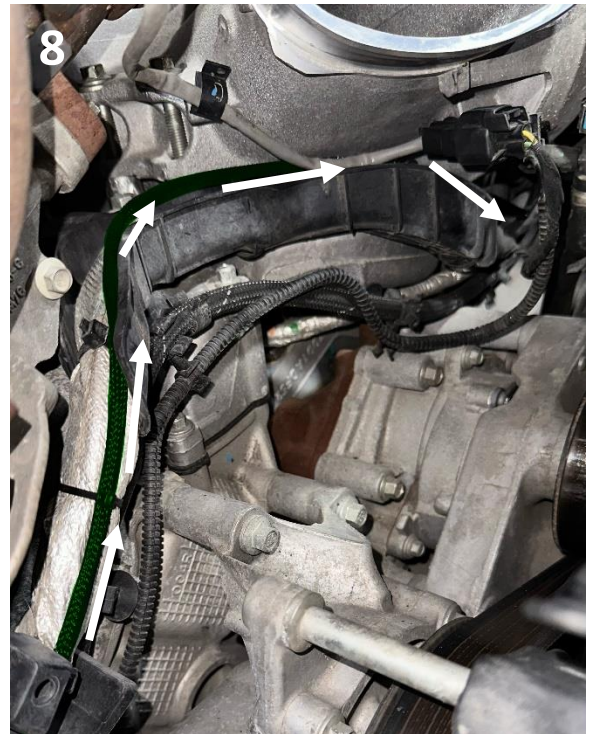
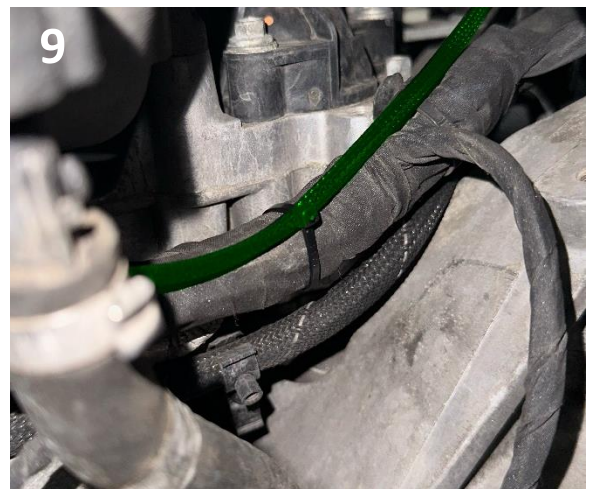
STEP 8: Continue to route the alternator signal harness along the OE harness underneath the EGR cooler and into the harness tray underneath the air intake.

Continue routing the alternator signal harness up and through the plastic tray towards the driver's side of the vehicle. Use the included zip ties at evenly spaced intervals to retain the wire to the existing electrical harness. Leave enough slack in the wire for the connector to reach the alternator.

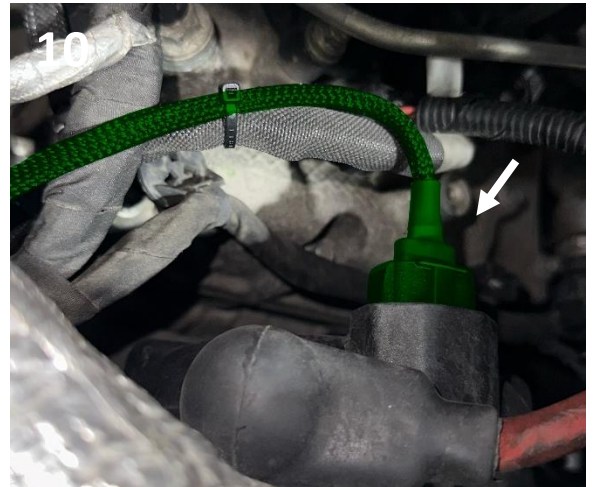
STEP 9: Connect the end of the harness to the alternator. Use another zip tie to retain the signal wire as shown.
