## INSTALLATION INSTRUCTIONS

### SUBJECT: Heater Feed and Return Hose Kit for 1998.5-2002 Cummins

**FITMENT:** 1998.5-2002 5.9L 24V Cummins Equipped Dodge Ram 2500/3500 Pickup Trucks

**KIT P/N:** FPE-CUMM-HCL-KIT-9902

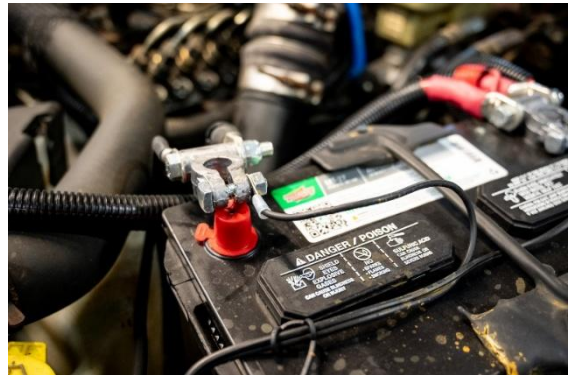
**STEP 1:** Park the vehicle on a level surface, then using a 13MM socket or wrench disconnect each of the negative battery terminals and isolate.

**Figure 1:** Negative battery terminal disconnected and isolated.

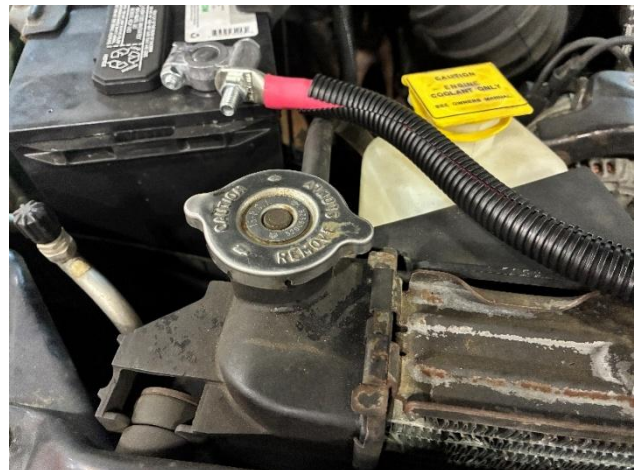
Relieve pressure from the cooling system by placing a shop rag over the top of the radiator cap, then slowly twist the cap counterclockwise. The shop rag will provide a layer of protection from any remaining heat or steam that may escape from the radiator during this process.

**Figure 2:** Radiator cap and cooling reservoir at right.

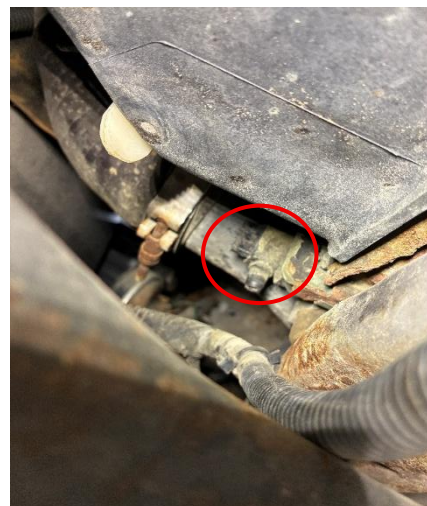
Once the cap is fully removed, locate the coolant drain on the driver's side of the radiator. Turn the knob counterclockwise (circled in figure) and allow the coolant to drain into a clean drain pan.

**Figure 3:** Radiator petcock circled.

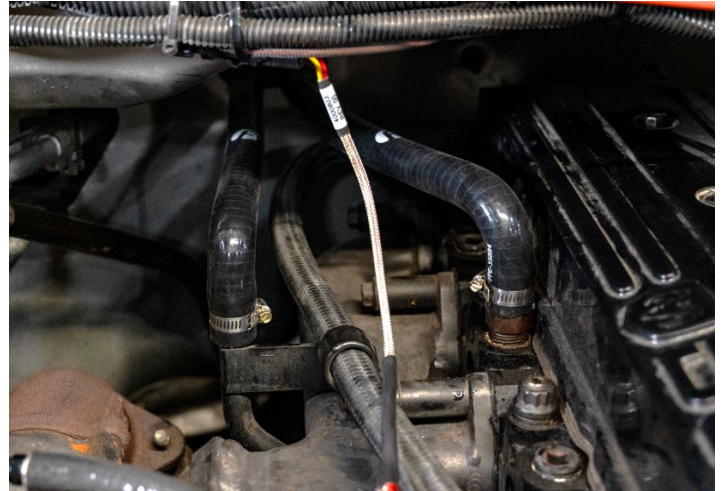
With the hoses properly fitted, install the hose clamps onto both ends of each hose. Connect the hose ends to the heater core, standpipe, and cylinder head fitting. Tighten the hose clamps using a flathead screwdriver or  $\frac{1}{4}$ " socket.

*Figure 6: New Fleece heater core lines installed, supplied hose clamps installed.*

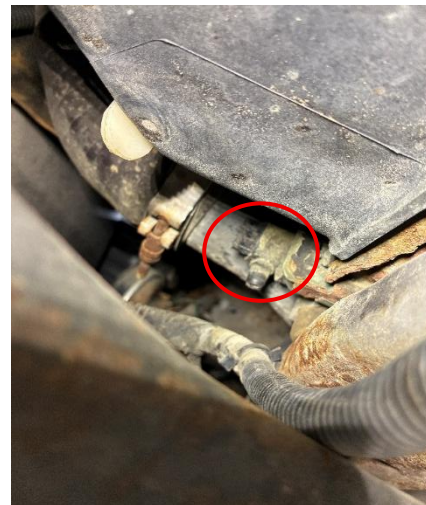
**STEP 6: Turn the radiator petcock clockwise to the closed position then re-fill the coolant system.** Re-use or replace coolant as necessary to properly fill the system with clean fluid. Reinstall the radiator cap and ensure the cooling reservoir is at the correct level.

*Figure 7: Radiator petcock circled.*
