## INSTALLATION INSTRUCTIONS

### SUBJECT: Heater Feed and Return Hose Kit for 2003-2012 Cummins

**FITMENT:** 2003-2012 5.9L and 6.7L Cummins Equipped Dodge Ram 2500/3500 Pickup Trucks

**KIT P/N:** FPE-CUMM-HCL-KIT-0312

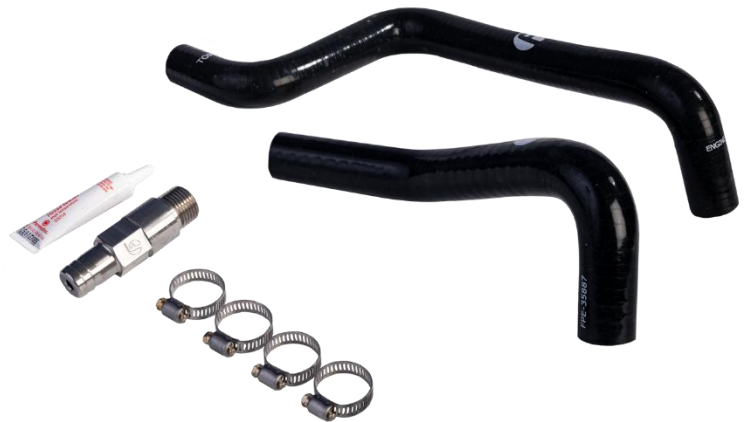
#### KIT CONTENTS:

| Item # | Description | QTY |
| 1 | Upper heater core hose (supply) | 1 |
| 2 | Lower heater core hose (return) | 1 |
| 3 | Upper heater core hose riser adapter | 1 |
| 4 | Hose clamp | 4 |
| 5 | Thread sealant | 1 |

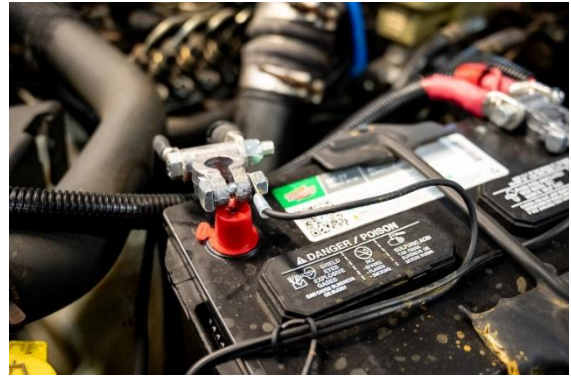
**STEP 1:** Park the vehicle on a level surface, then using a 13MM socket or wrench disconnect each of the negative battery terminals.

Figure 1: Negative battery terminal disconnected and isolated.

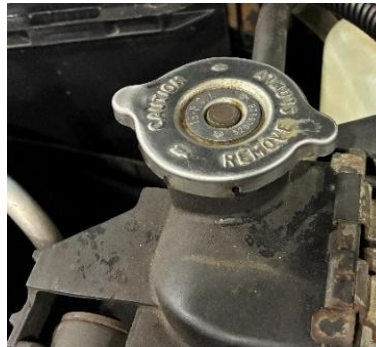
Relieve pressure from the cooling system by placing a shop rag over the top of the radiator cap, then slowly twist the cap counterclockwise. The shop rag will provide a layer of protection from any remaining heat or steam that may escape from the radiator during this process.

Figure 2A: Radiator cap.

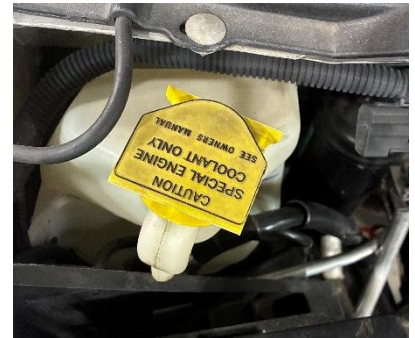
Figure 2B: Coolant overflow bottle.

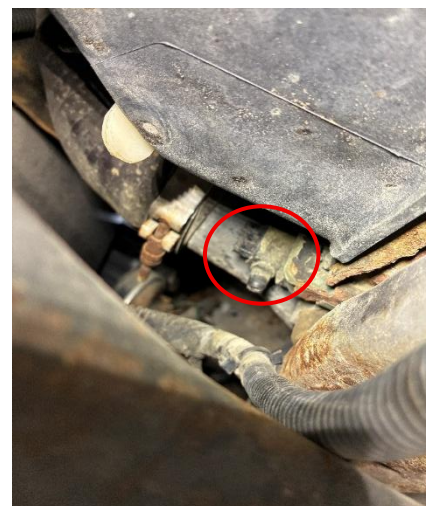
Once the cap is fully removed, locate the coolant drain on the bottom of the radiator. Turn the knob counterclockwise (circled in figure) and allow the coolant to drain into a clean bucket or pail.

Figure 3: Radiator petcock circled.

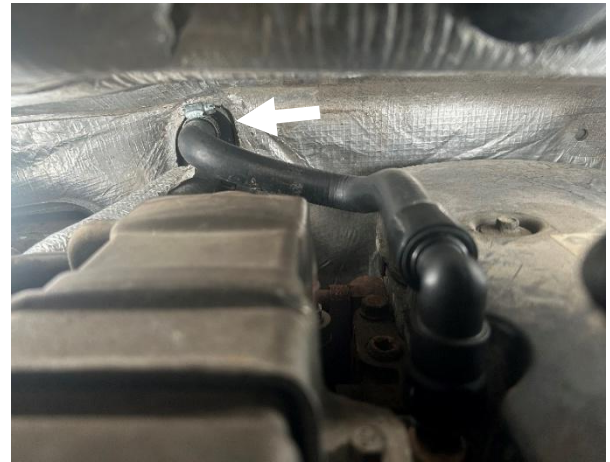
**STEP 3:** Locate the upper heater core supply hose in the engine bay located on the (left) passenger side of the engine valve cover. Remove the hose clamp from the upper heater core hose at the firewall heater core connection.

Figure 4: Upper heater core supply hose, hose clamp highlighted with arrow.

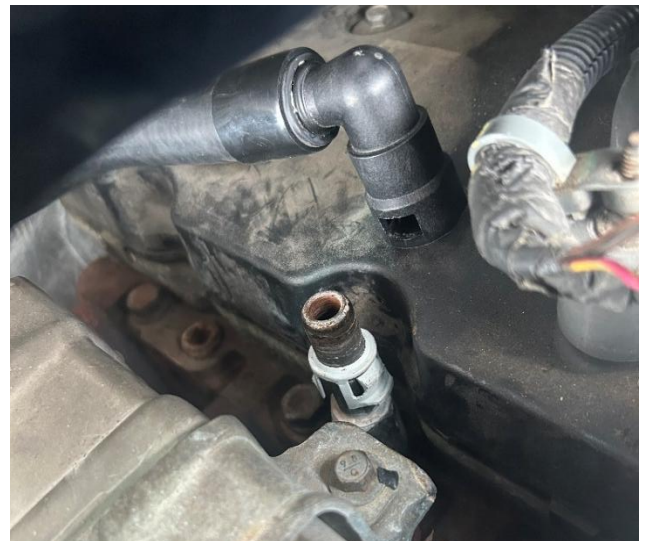
Disconnect the heater core hose from the quick disconnect fitting on the passenger side of the cylinder head. Compress the hose locking tabs and lifting up on the connection. If necessary, use a flat head screwdriver to pry the hose adapter from the fitting. Remove the upper heater core hose from the engine bay.

Figure 5: Stock heater core hose and OE adapter fitting.

*The OE quick disconnect fitting and the Fleece Performance riser fitting both contain a flow control orifice to manage overall coolant flow to the heater core.*

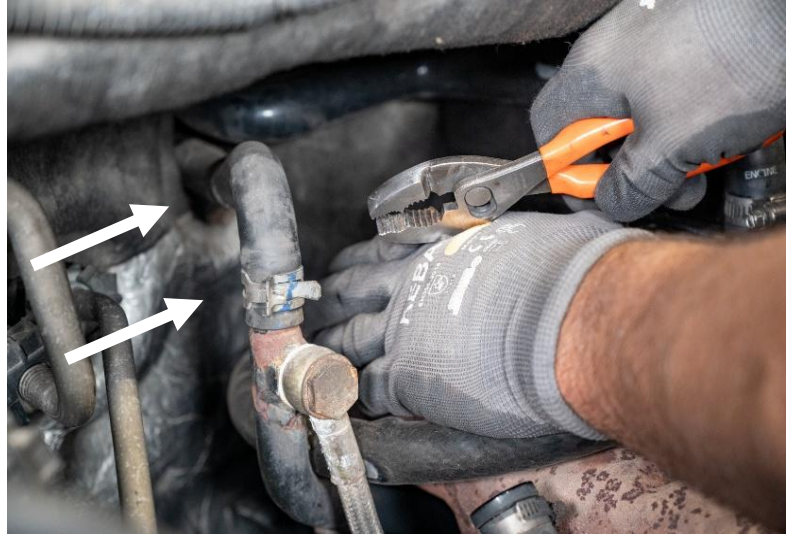
**STEP 6:** Locate the lower heater core return hose in the engine bay located on the (left) passenger side of the engine on the top of the coolant standpipe.

*Figure 6: Stock lower heater core return hose. Arrows highlighting each clamp.*

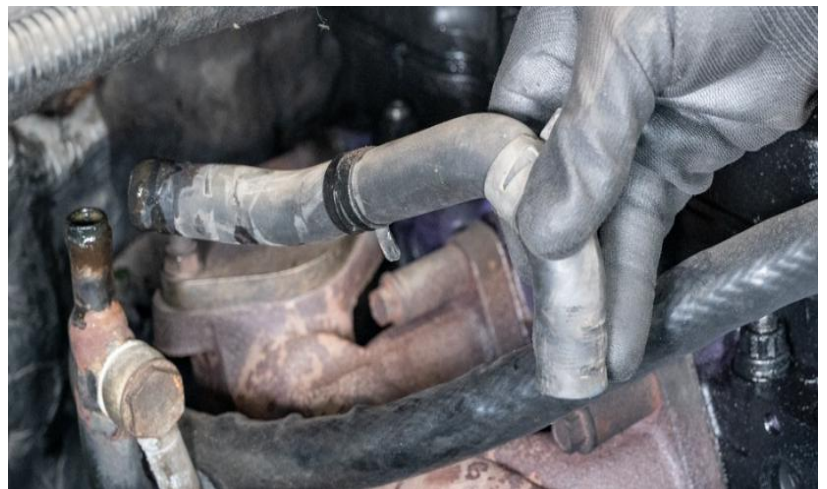
**STEP 7:** Disconnect the lower heater core hose from the coolant standpipe and the firewall.

*Figure 7: Removal of lower heater core return hose.*

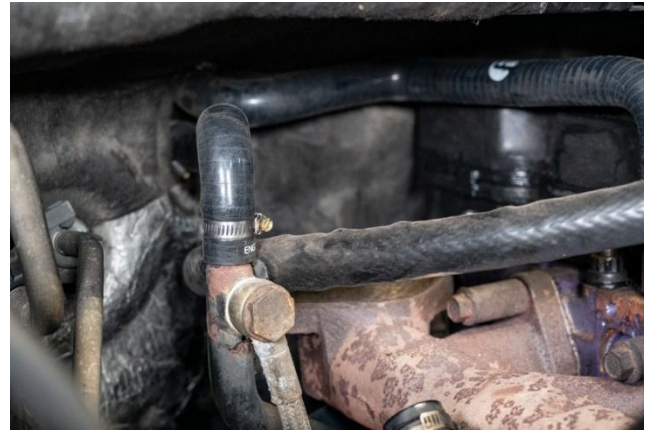
Install the included hose clamps onto the hose. Connect the hose to the lower heater core port on the firewall and the coolant standpipe. Tighten the hose clamps using a ¼" socket or flathead screwdriver.

*Figure 8: New Fleece heater core line installed, included hose clamps installed.*

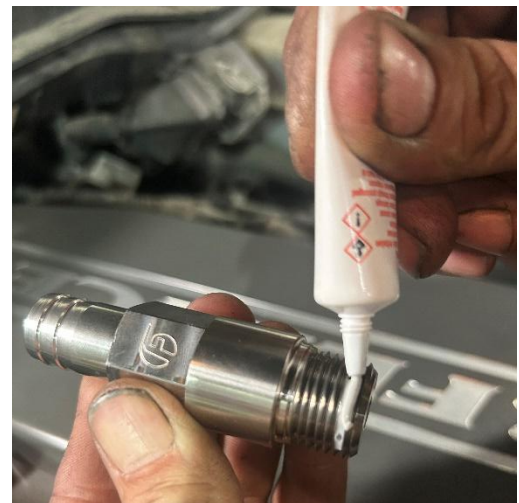
**STEP 9: Apply thread sealant in a single bead around the lowest thread of the new heater core hose riser fitting.**

**NOTE:** The included Permatex thread sealant requires up to 24 hours to cure. Please allow for appropriate time for the sealant to fully cure. If a more immediate application is required, Teflon tape can be used instead of the provided Permatex sealant.

*Figure 9: New Fleece heater core line installed, included hose clamp installed.*

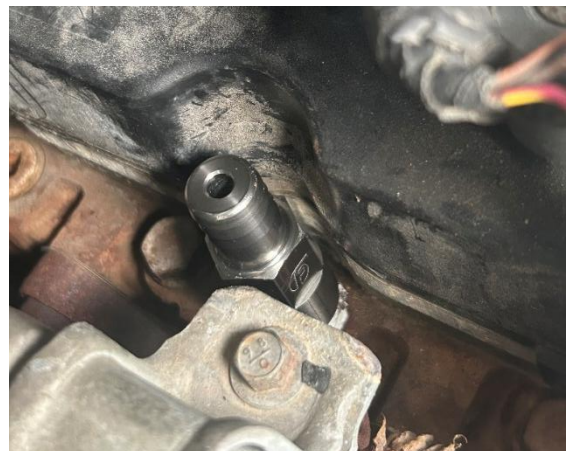
**STEP 10: Using a 7/8" deep well socket, install the new Fleece Performance riser fitting into the cylinder head port where the OE fitting was removed.**

*Figure 10: New Fleece heater core line installed, included hose clamp installed.*

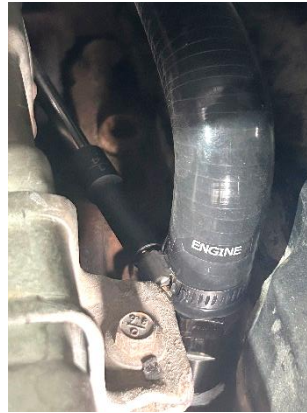
Connect it to the upper heater core port at the firewall and the new riser fitting installed on the cylinder head. Use the supplied hose clamps to secure both ends of the hose and tighten them with a 1/4" socket or flat head screwdriver.

*Figure 11: New Fleece heater core line installed, included hose clamp installed.*

*Figure 12: New Fleece heater core line installed, included hose clamp installed.*

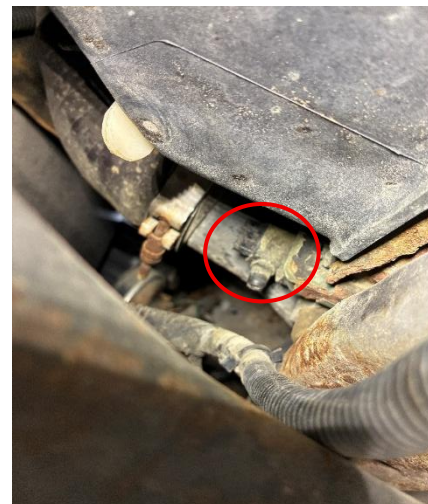
**STEP 12: Turn the radiator petcock clockwise to the closed position then re-fill the coolant system.** Re-use or replace coolant as necessary to properly fill the system with clean fluid. Reinstall the radiator cap and ensure the cooling reservoir is at the correct level.

*Figure 13: Radiator petcock circled.*

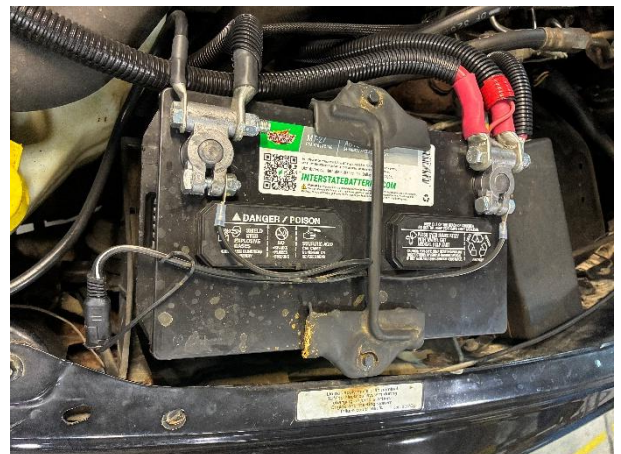
**STEP 13: Re-connect each negative battery terminal.**

**STEP 14: Start the truck and allow the engine to idle.** Bring the engine to normal operating temperature and confirm that no leaks are present. Inspect all fittings and lines. Check the cooling reservoir once more and top off as needed.

*Figure 14: Negative battery terminal reinstalled.*
